NewGen Neerabup Gas Pipeline Fauna Clearance Summary

Issued:
Prepared by:
For NewGen Neerabup Pty Ltd

Rev No	Date	Description	Prepared By	Reviewed by	Approved By
a	5/08/09	Fauna Pipeline Clearance Summary	Pat Cullen

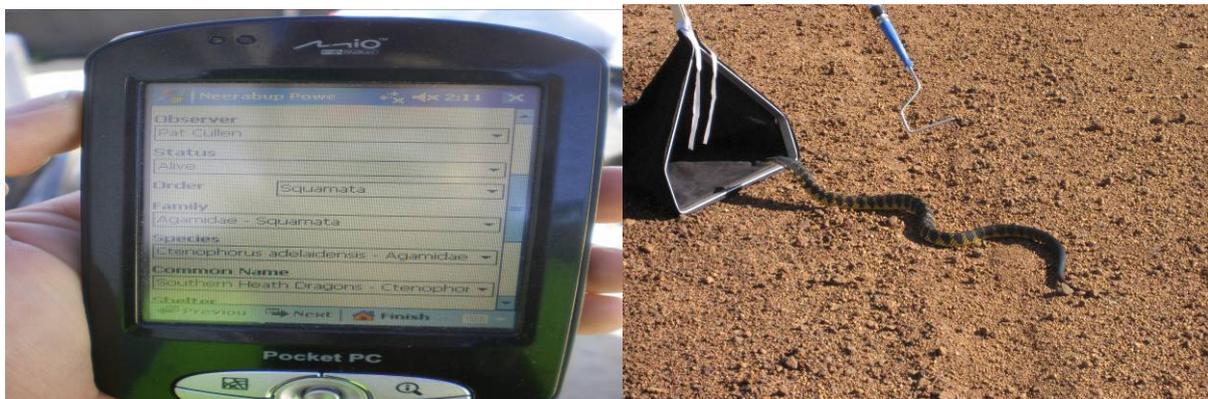
Plate 3.5 GPS Enabled Data Kit and extendable net and jigger for capturing fauna

The fauna handler's equipment included a PDA with GPS function to record all fauna data (plate 3.5), extendable net and jigger, snake bandages, digital camera, radio communication, calico bags, gloves and zoological field guides and keys.
